Petrochemical company uses online information to keep critical machine running

Gulf Petrochemical Industries Company, Bahrain

by **Ron Bosmans**
Principal Engineer
Bently Nevada Corporation

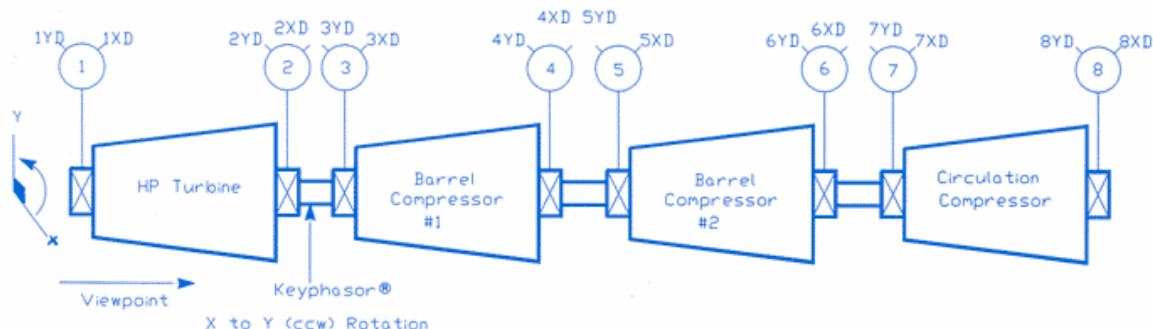
Figure 1
Makeup gas compressor train

tenance Section. The machine train consists of a mechanical drive steam turbine, two barrel compressors, and a circulation compressor. An analysis of this machine train was conducted on December 11, 1994.
